Job No. W07225

Site Classification Report

Proposed Shed

Inglewood Macintyre Sports Complex

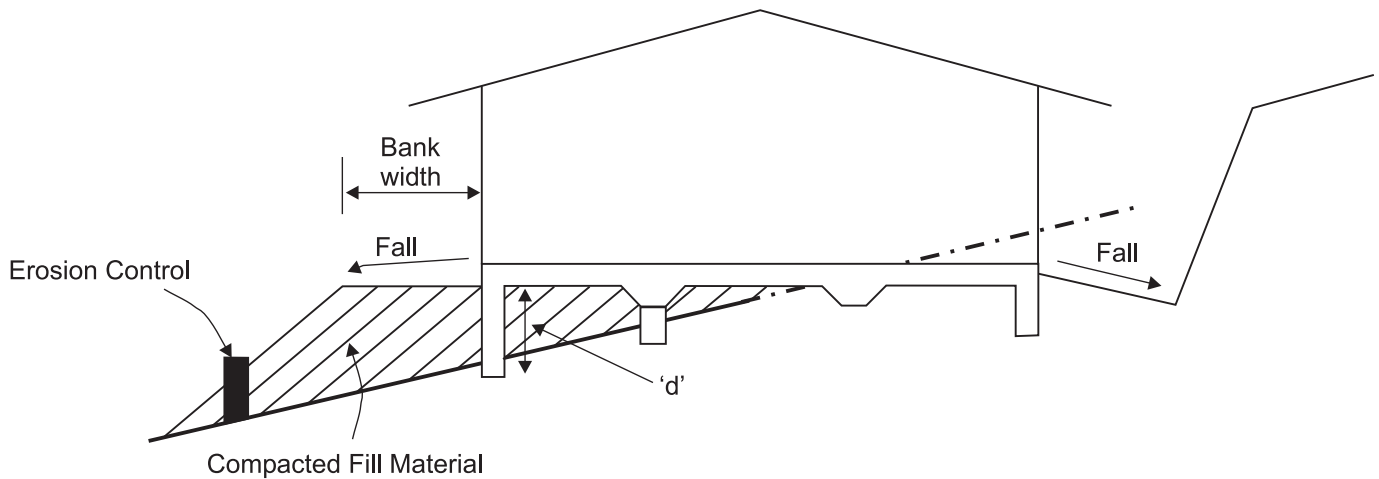
SITE EARTHWORKS

1. Bank Width - 1800mm or:
 - (a) 1.5d for Weathered Rock or well graded Granular fill:
 - (b) 2.0d for Clays or silty, sandy and gravelly Clays: Silts,
 - (c) 3.0d for sands and soft Clays.
2. Where the specified Bank Width above cannot be achieved, an Engineer should be consulted for a Retaining Wall &/or Pier Design.
3. All organic matter should be removed from the intended building site prior to construction of the foundations.
4. If any trees are removed to be removed, the grubholes shall be backfilled and compacted according to Note 5.
5. Any material used as fill underneath the intended building shall be built up in layers of 150mm moistened and compacted with suitable compaction equipment to 95% Standard Compaction in accordance with AS 3798.

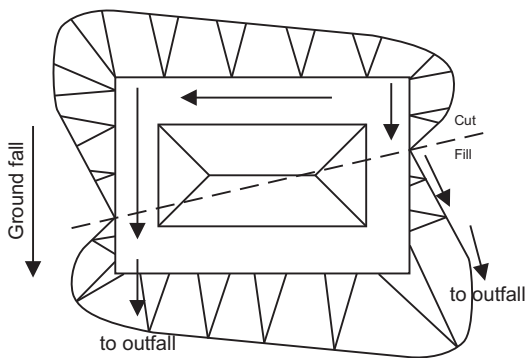
TYPICAL DRAINAGE LAYOUT
FOR CUT/FILL SITES

1. It is extremely important to maintain good drainage throughout constructions of any building
2. Fall away from the building shall be 50mm for the first metre so water does not pond against or near the building
3. All water run-off shall be channeled away from the building at all times pre & post construction
4. For flat sites, an Engineer should be consulted to ensure that the finished height of the building allows proper drainage away from the building
5. Drainage must not direct water to adjacent blocks in a concentrated form
